PLANNING AND ENVIRONMENTAL IMPACT ASSESSMENT

Padeswood Cement Mill 5 - Phase 1 Contaminated Land Assessment

Report **Number** 1773079.504/A.3

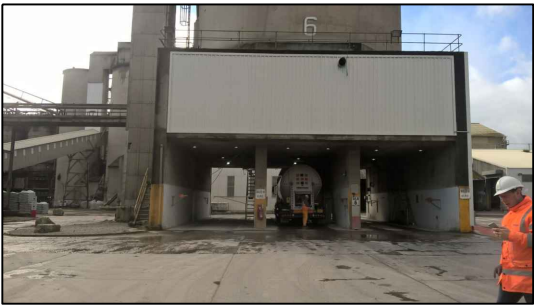
PHOTO 1: CEMENT LOADING

In the western side of the Site, a small electrical sub-station was located adjacent to the limestone crusher building, a boiler was located by the disused railway line and truck loading of cement was observed to take place beneath Silo number 6. All activities were on hard-standing. No visual evidence of contamination, such as staining, was observed.

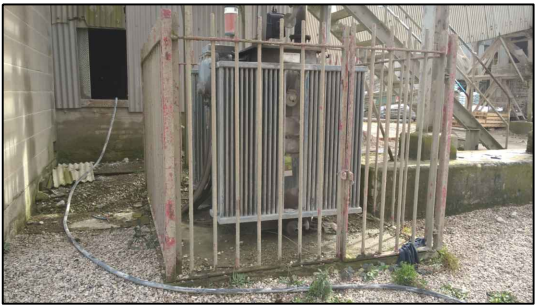
PHOTO 10: ELECTRICAL SUB-STATION

The electrical sub-station located by the limestone crusher building could contain, or have contained in the past, oil-filled transformers containing PCBs (Polychlorinated Biphenyls). There was no visual evidence of staining in the ground adjacent to the sub-station. The limestone crusher building is proposed to remain in place.

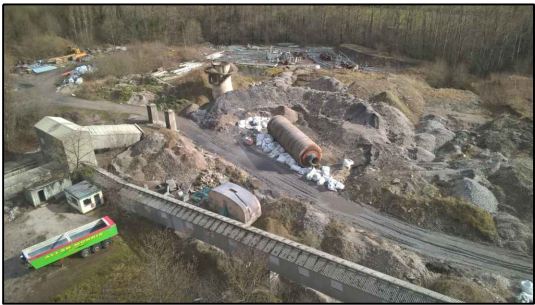
PHOTO 2

Part of the Site is currently used as general open storage. In the northern part of the Site, in an area of raised Made Ground, open storage of bags of cement was observed to take place. A disused vertical mill structure was also found in this area. No visual evidence of contamination was observed on the surface although the raised Made Ground itself is likely to comprise of construction waste and waste arising from the Cement Works' workshop. This area extends further north outside the boundary of the proposed development. Metal bars (to the east) and cabin containers containing open drums of fuel and grease (to the north) are located in the area. The stored fuel and grease were thought to have been used in the servicing of Cement Works vehicles (a disused vehicle was parked in the vicinity). This activity is thought to have been ceased. No visual evidence of contamination was observed in the surrounding soil. Additionally, wood pellets, tyres and plastic sheeting were observed to be stored in the area.

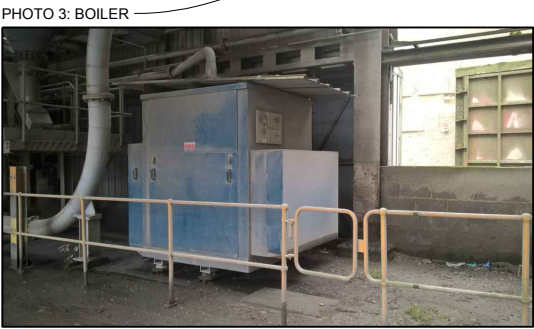
PHOTO 3: BOILER

The boiler located in the area of the disused railway line may have the potential to contaminate the surrounding ground with oils. However, the boiler was observed to be in a good state of repair during the Site walkover and no evidence of staining was observed in the surrounding ground (hard-standing). The boiler may need removing for the proposed new rail loading facility.
